## Material Handling

### True North Forklift Sales

Monitoring Specific Gravity of a forklift used at grocery shop in Auburn, WA

<b>Test date:</b>	June 2005	
<b>Place:</b>	Grocery Shop in Auburn, WA	
<b>Lift Truck:</b>	Electric Clark Lift	
<b>Battery Spec.:</b>	Maker	GNB Technologies
	Model	M2601812517B
	S/N	GCZ0835
	Capacity	1000 Ah
	Voltage	36V
	Yr. Made	2001

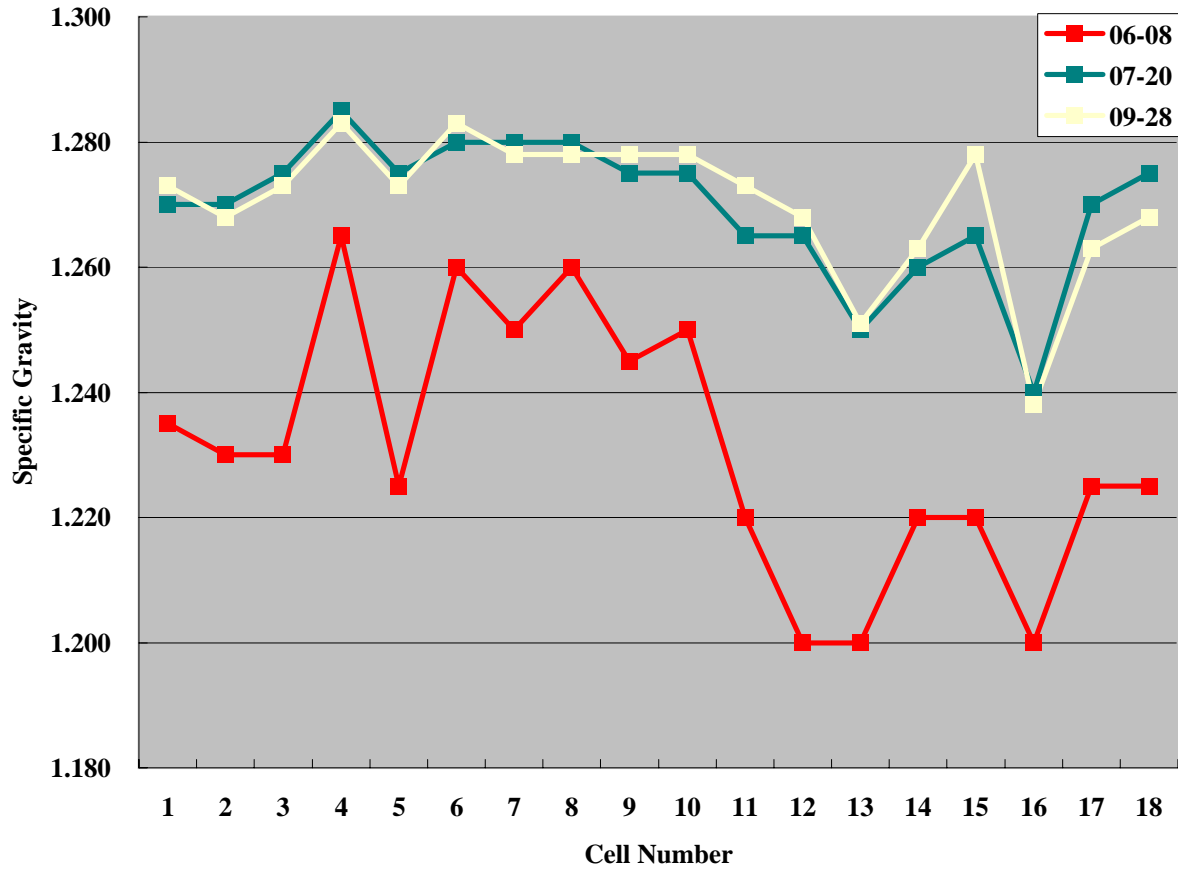
Change in Specific Gravity - TNFS @ Grocery Shop.

Cell / Date	06-08	07-20	09-28
1	1.235	1.270	1.273
2	1.230	1.270	1.268
3	1.230	1.275	1.273
4	1.265	1.285	1.283
5	1.225	1.275	1.273
6	1.260	1.280	1.283
7	1.250	1.280	1.278
8	1.260	1.280	1.278
9	1.245	1.275	1.278
10	1.250	1.275	1.278
11	1.220	1.265	1.273
12	1.200	1.265	1.268
13	1.200	1.250	1.251
14	1.220	1.260	1.263
15	1.220	1.265	1.278
16	1.200	1.240	1.238
17	1.225	1.270	1.263
18	1.225	1.275	1.268
<b>Average S.G.</b>	<b>1.231</b>	<b>1.270</b>	<b>1.270</b>

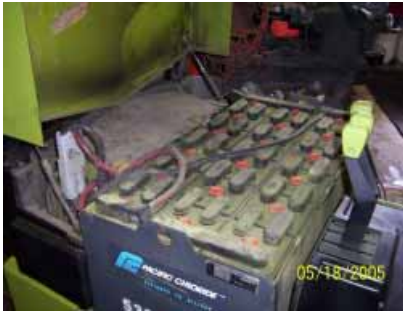
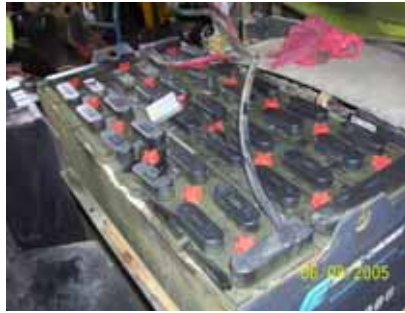
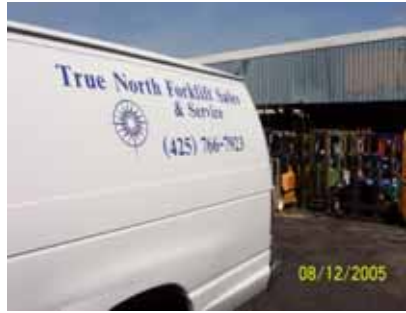
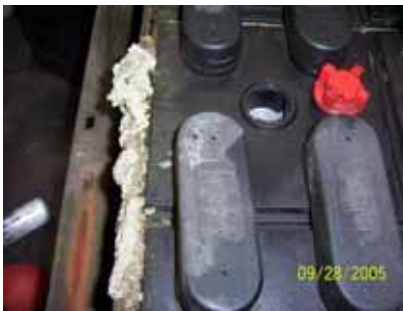
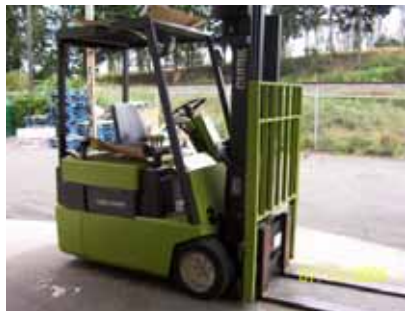
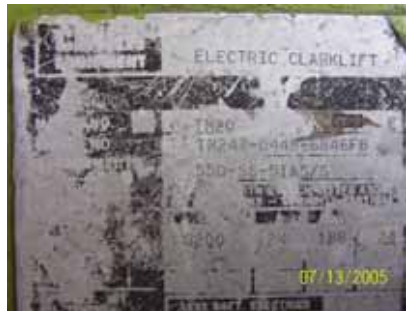
White deposit is growing on cel 16 & 17. (Showing physical damage.)

6-6-05	Battery was charged on an automatic charger twice, however it did not seem to be charged fully. Therefore, it was on a timer charge for two days, 11 hours each day.
6-8-05	After equalization charge SG readings were taken, then Nanopulser was installed. Until delivery to grocery shop, battery was left unattended with Nanopulser installed.
6-30-05	Forklift with the battery and a charger were delivered to grocery shop in Auburn, WA. After delivery, battery was charged.
7-19-05	Equalized for SG reading a day before measurement.
7-20-05	SG was measured, 10:00 AM in the morning,. Cell number 9, 10, 12, 13, 14, 15 were dry and after measurement filled with water.
In between	Charger's fuse was out and it took a long time to fix. Charger was replaced with a different charger. -- see photo.
9-27-05	12 hour equalization charge was performed.
9-28-05	S.G. reading and Voltage w/ and w/o load were measured. Specific Gravity improved in first 6 weeks, then maintained. Even initial SG improvement can be seen on cell #16, as seen on photo, white sulfation buildup on top of the case showing physical damage. To confirm the damage, voltage of each cells were recorded.
